Update on Restoration of No. 460, the Lindbergh Engine. November 18, 2010

Parts Are Cast For No. 460

RESTORATION UPDATE: PRR NO. 460

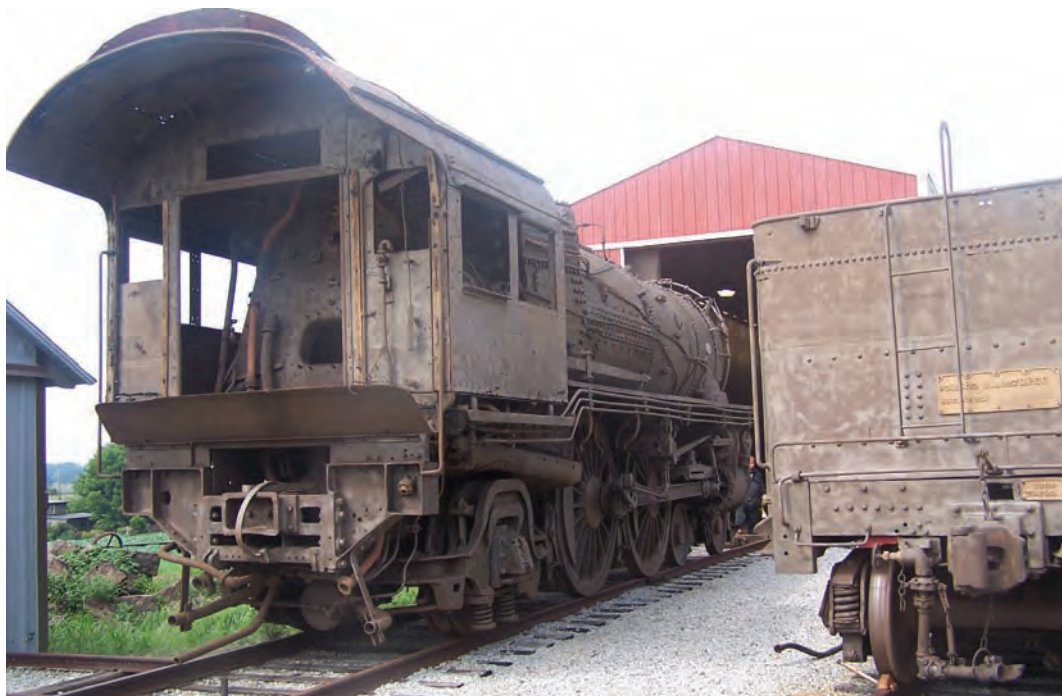
PHOTO ABOVE: Following the removal of the lead-based paint, No. 460 and her tender briefly rest outdoors as the environmental cleanup of the Museum's paint shed begins in earnest. The locomotive and tender moved back inside that afternoon, August 31, 2010. (Allan C. Martin Photo, Railroad Museum of Pennsylvania, PHMC)

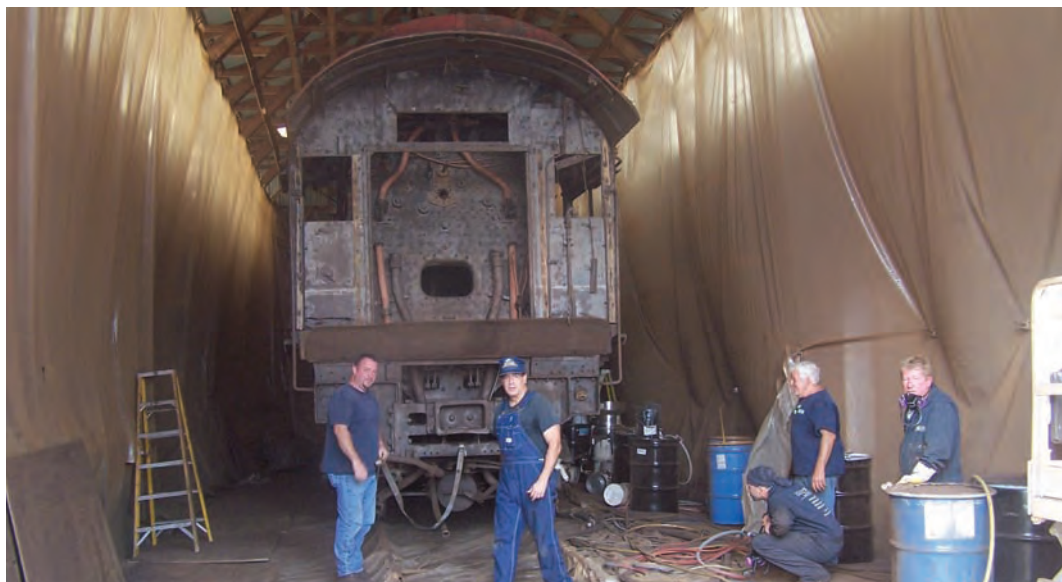
PHOTO BELOW: A look inside the paint shed. Railroad Museum of Pennsylvania employees Shawn O'Brassill and Steve Meola assist employees of the I. K. Stoltzfus Service Corporation during a break in the action on August 18, 2010. (Allan C. Martin Photo, Railroad Museum of Pennsylvania, PHMC)

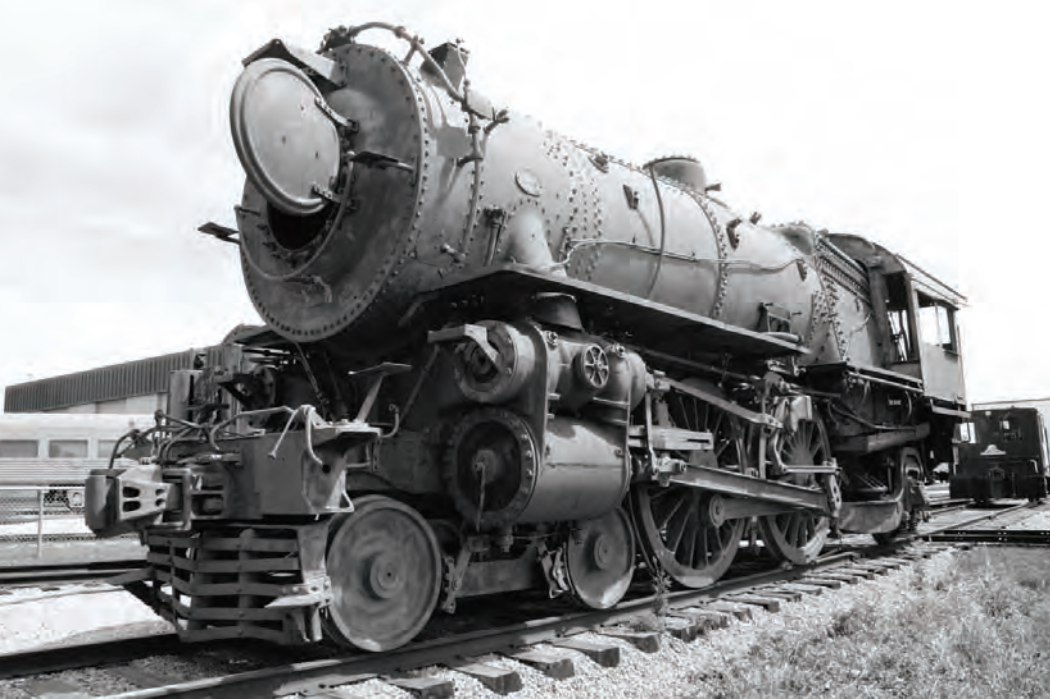
PHOTO ABOVE: *With all her paint removed, PRR No. 460 looks something like a full-scale, unfinished model kit. This is the first time that anyone has had this view of the Lindbergh Engine in nearly 60 years. (Ryan C. Kunkle Photo, Railroad Museum of Pennsylvania, PHMC)*

under the locomotive and tender. With the locomotive and tender sitting outside, we had a chance to photograph the locomotive and tender without any paint covering the metal. We were astonished just how well the sponge blast media had actually removed the many layers of old lead paint, providing a perfect 4 mil profile (roughness) on all surfaces. This is an ideal surface to which new paint can bond.

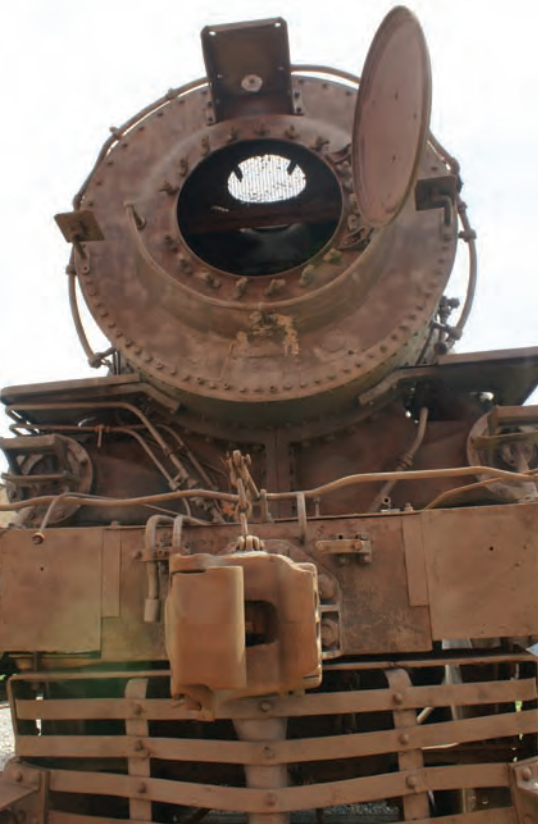
PHOTO BELOW: *Sunlight streams through an open stack and smoke box door, revealing deflector plates and screens inside. (Ryan C. Kunkle Photo, Railroad Museum of Pennsylvania, PHMC)*

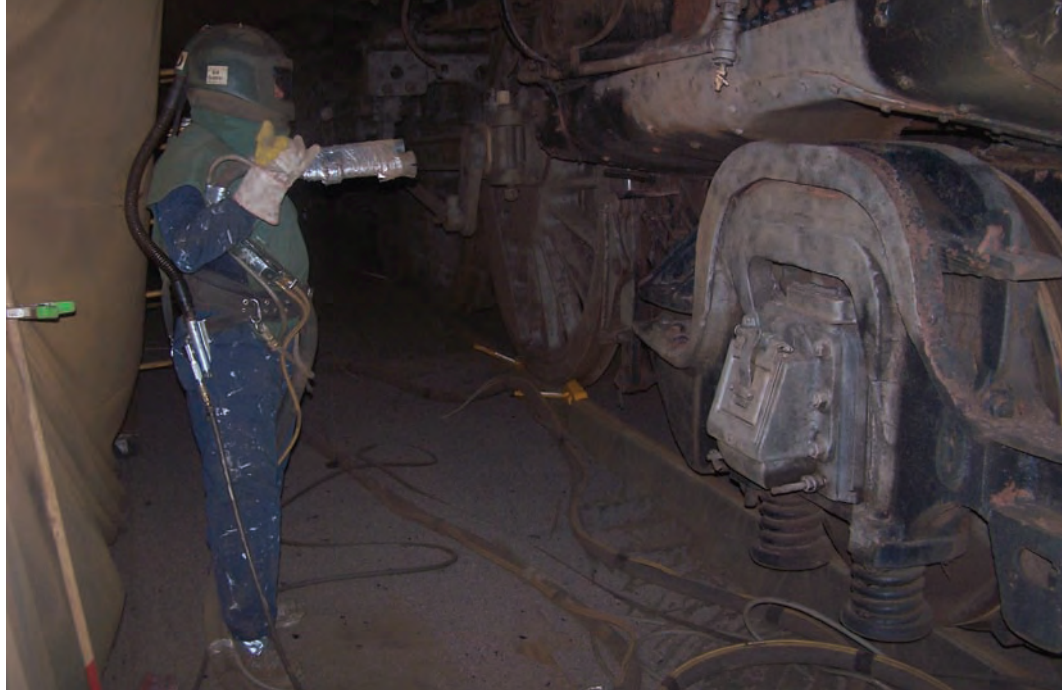
PHOTO ABOVE: An I. K. Stoltzfus employee removes grease, rust and lead-based paint from the ash pan and KW trailing truck of No. 460. (Allan C. Martin Photo, Railroad Museum of Pennsylvania, PHMC)

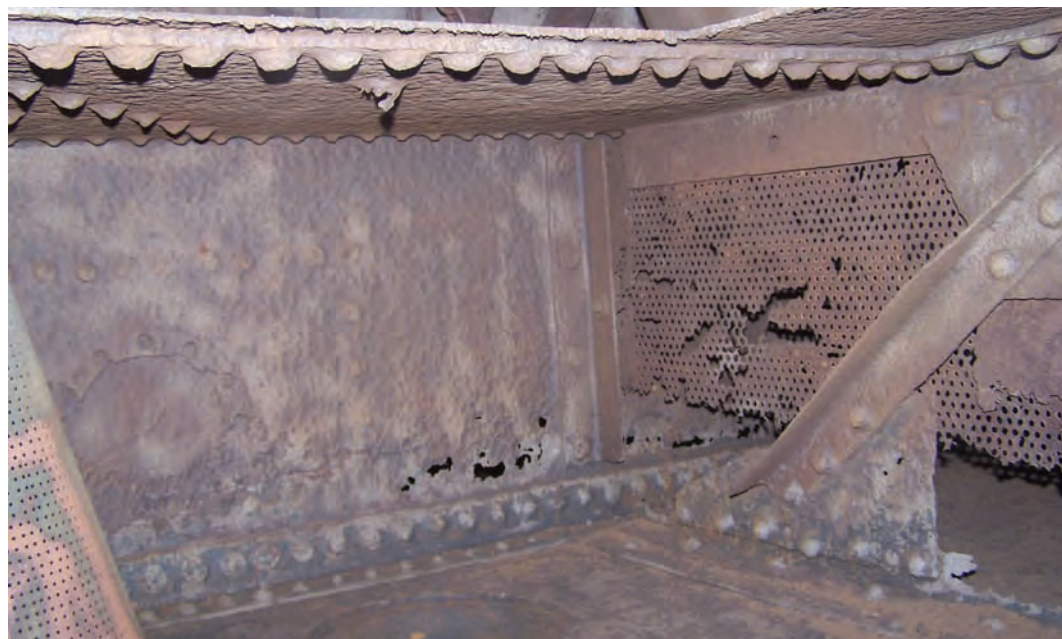
PHOTO BELOW: The interior of the water tank of tender No. 1565 now reveals details of the interior structure, after sponge blasting to remove rust and debris. (Allan C. Martin Photo, Railroad Museum of Pennsylvania, PHMC)

On Wednesday, August 18, 2010, restoration technicians Steve Meola and Shawn O’Brassill removed four large sections of the top of the tender with a plasma torch to allow I. K. Stoltzfus to sponge blast the interior of the tender water tank. Blasting of PRR No. 460 officially ended on Friday, August 27, 2010. 🟡

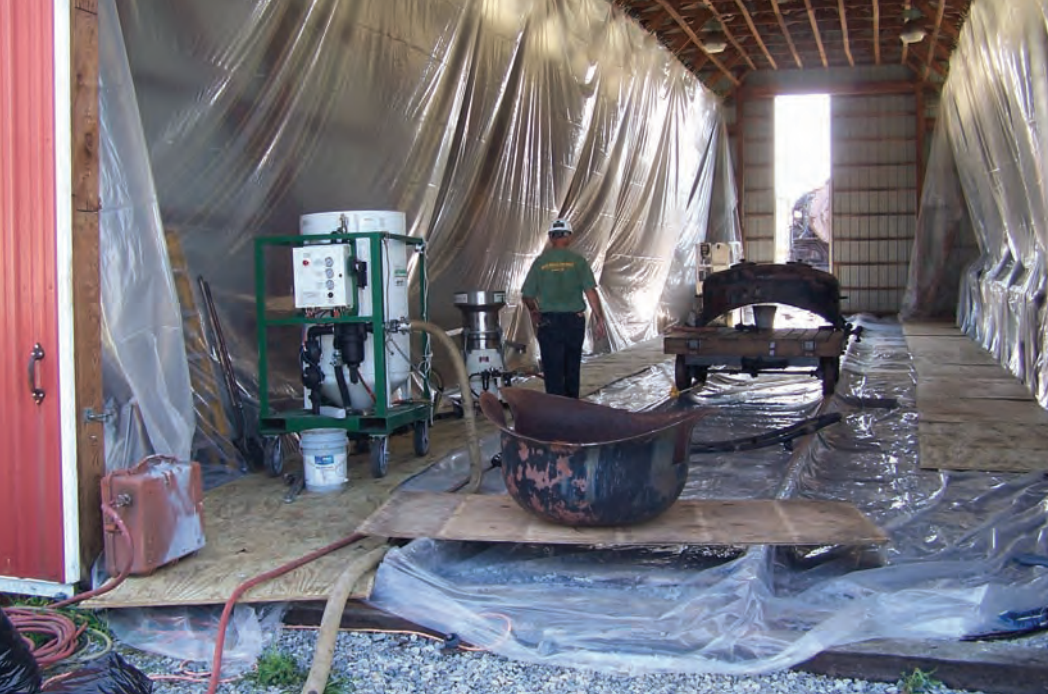
PHOTO ABOVE: *The project got underway with the removal of the paint covering No. 460's sand and steam domes. The interior of the paint shed was draped in plastic sheeting to aid in post-project cleanup. (Allan C. Martin Photo, Railroad Museum of Pennsylvania, PHMC)*

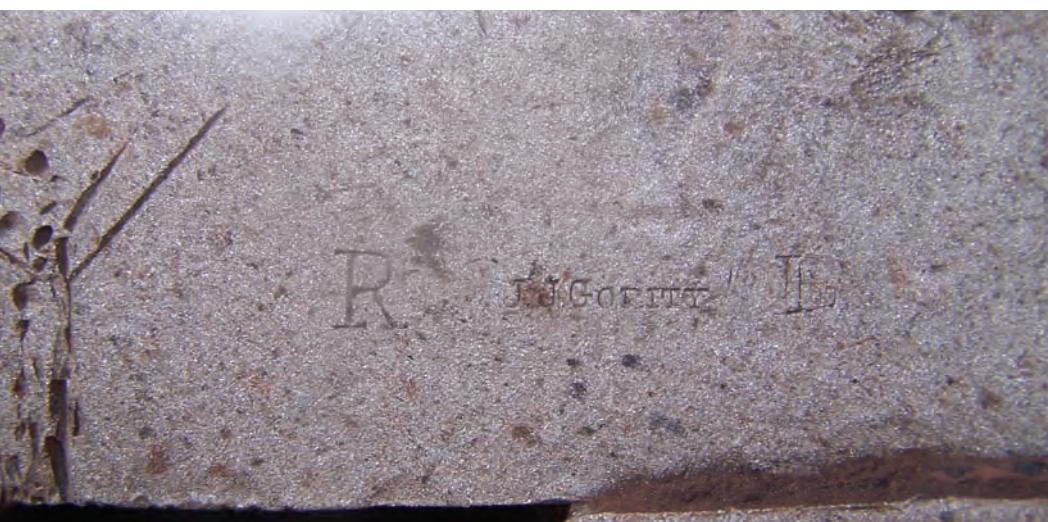
PHOTO BELOW: *Among the many details revealed through the paint removal process are the timing marks left by J. J. GORITY on the right side crosshead guide of the locomotive. (Ryan C. Kunkle Photo, Railroad Museum of Pennsylvania, PHMC)*

previously concealed under a quarter of an inch of paint were now revealed. We found original timing marks that had been punched into the crosshead guides on both sides of the locomotive and the name "J. J. GORITY" was found stamped into the crosshead guide on the engineer's side of the locomotive. Mr. GORITY apparently stamped his name on the crosshead guide after setting the timing for the locomotive.

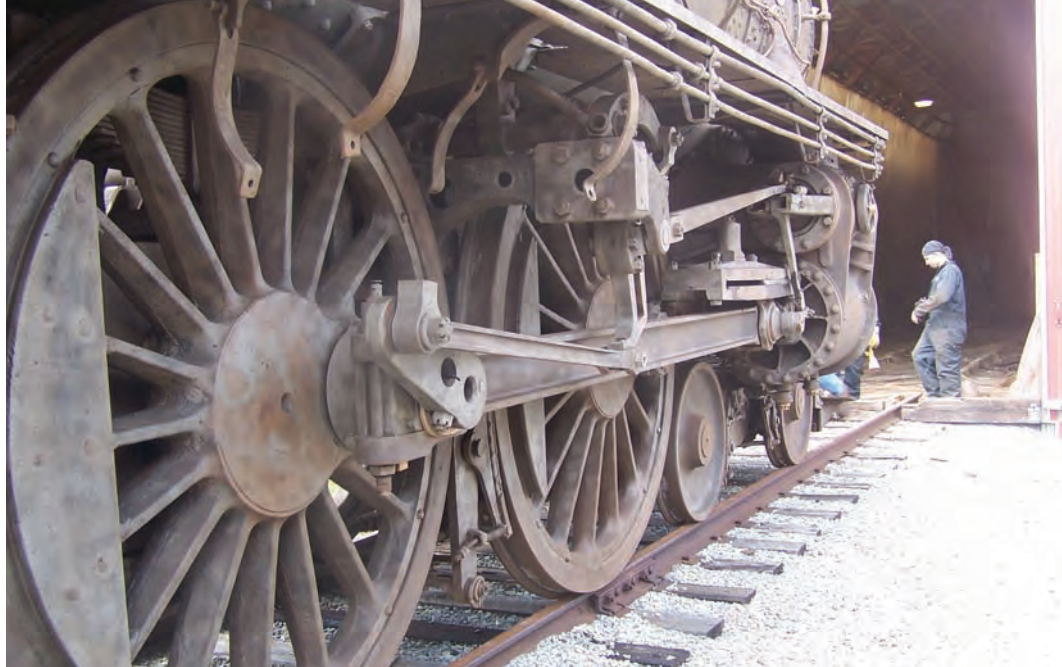
PHOTO ABOVE: This is a view of No. 460’s running gear after paint removal. Subsequent investigation showed the engineer’s side drive wheels originated from sister E6s locomotive No. 1565. (Allan C. Martin Photo, Railroad Museum of Pennsylvania, PHMC)

Continued examination of locomotive No. 460 also showed that it contained many parts originally manufactured for other E6s locomotives. The drive wheels on the fireman's side of the locomotive were number stamped 460, while those on the engineer's side were number stamped 1565. The number 1565 was also stamped on the valve stem crosshead on the engineer's side. Previously, we knew that locomotive No. 460 was coupled with the tender of locomotive No. 1565, but we did not realize there were other parts from No. 1565 installed on No. 460.

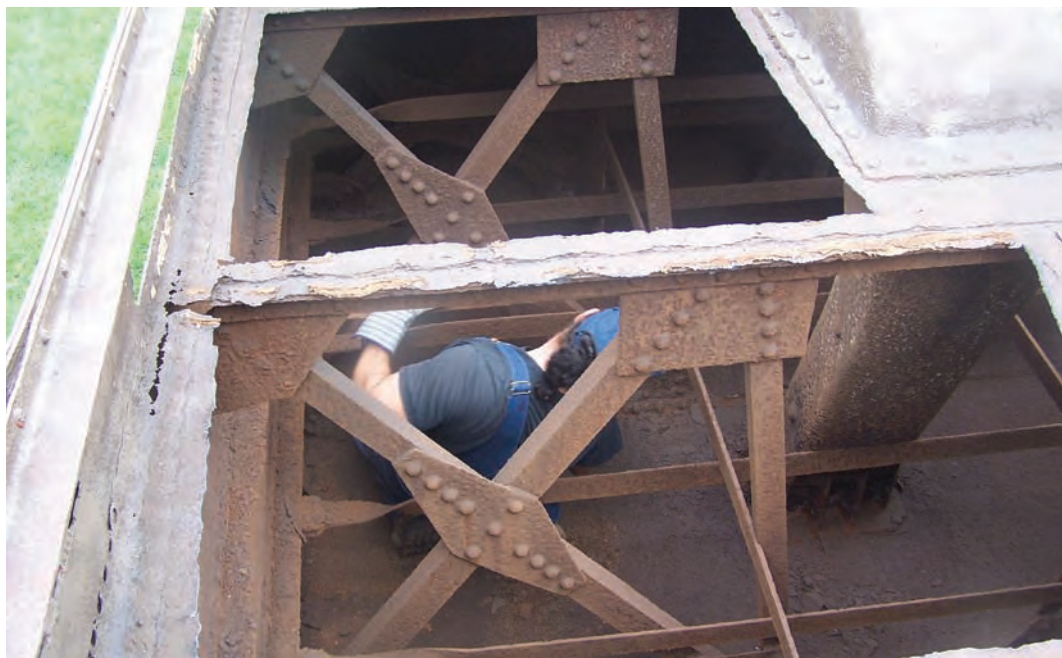
PHOTO AT CENTER: Several badly corroded sections of decking were removed from the tender in order to facilitate removal of rust from the interior. Museum employee Steve Meola is seen here inspecting the inner structure. (Allan C. Martin Photo, Railroad Museum of Pennsylvania, PHMC)

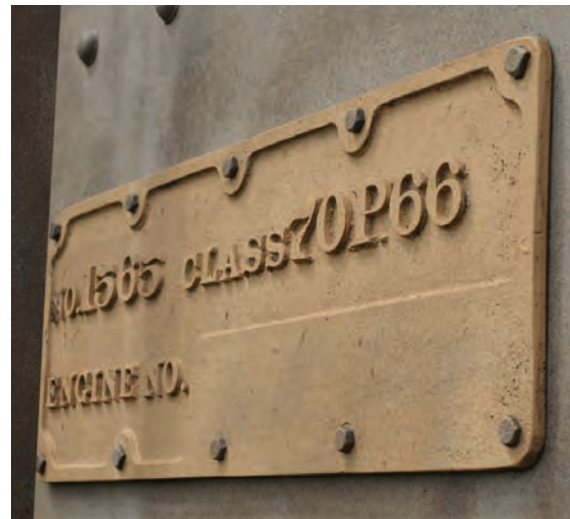
PHOTO BELOW: A brass plate identifies No. 460’s tender. Class 70P66 tender was designed for passenger service and held 7,000 gallons of water. (Ryan C. Kunkle Photo, Railroad Museum of Pennsylvania, PHMC)
